# Misting vs Leaking

MISTING SHOCKS ARE OFTEN **MISDIAGNOSED** AS FAILURES

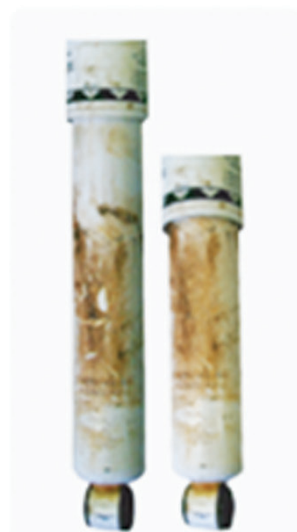
**MISTING**  
LIGHT DIRT ACCUMULATION

**OK**

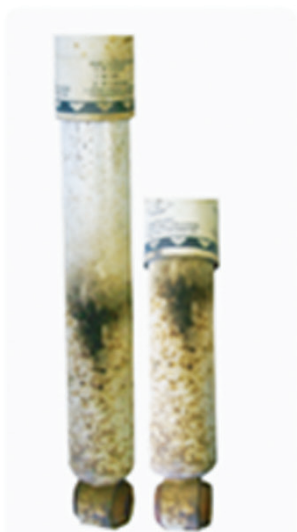
**MISTING**  
MILD DIRT ACCUMULATION

**OK**

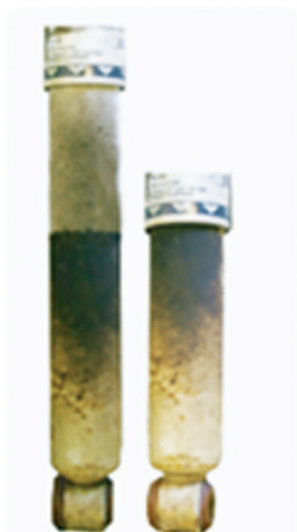
**MISTING**  
HEAVY DIRT ACCUMULATION

**OK**

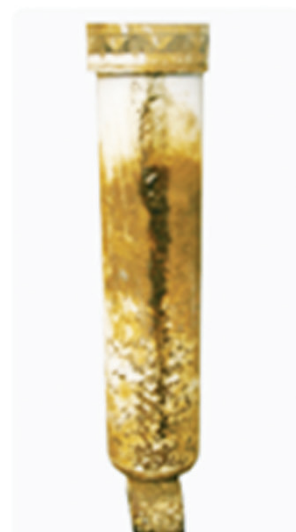
**LEAKING**  
WITH ASSOCIATED MISTING

**WARRANTY CLAIM**

**WET LINES OF OIL ARE VISIBLE**

An indication of a failed shock absorber is a thick wet layer of contaminant on the body of the shock or oil streaming off the body of the shock absorber over the lower mount.

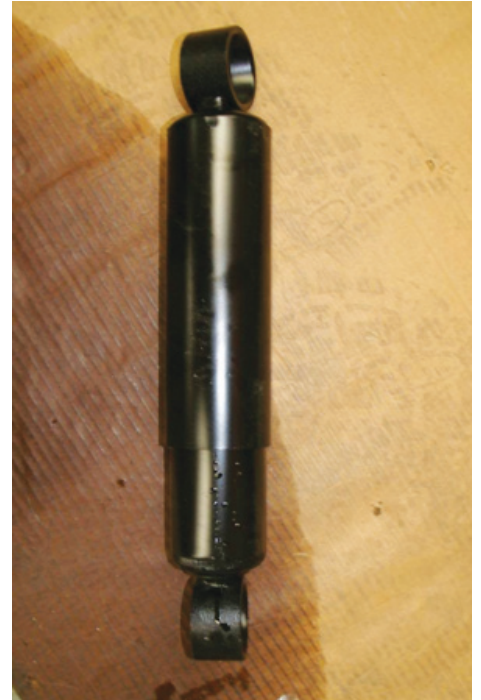
### **IF THE SHOCK ABSORBER HAS BEEN REMOVED**

### **IF OIL POOLS UNDER SHOCK**

valid warranty

**IF NO OIL POOLS**, probably misting shock. Clean shock and re-fit to vehicle and run for 48hrs, then re-inspect.

Request customer lay shock horizontal on a piece of cardboard for 48hrs.

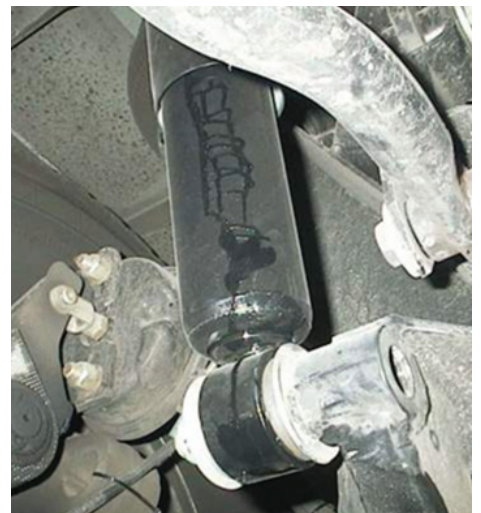
### **IF THE SHOCK ABSORBER IS STILL ON VEHICLE**

### **IF OIL STREAMS ARE EVIDENT OR IF OIL IS DRIPPING OFF THE LOWER MOUNT AFTER A 48 HR PERIOD**

valid warranty

**IF NO OIL STREAMS ARE PRESENT** shock absorber is deemed to be functioning normally.

Clean shock down and run vehicle for 48hrs
